LONDON FIRE BRIGADE

FIRE SAFETY GUIDANCE NOTE

Fires in Communal Areas - Information for External Partners

GN84

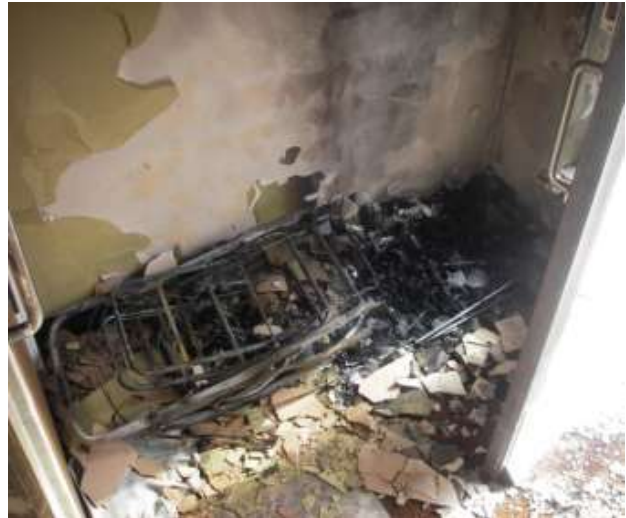
4.1 The image to the right shows a small buggy which was set alight in a very modern entrance area to a low rise block served by a single staircase and entrance. There was apparently very little additional fuel loading e.g. no toys and extra blankets.

4.2 The damage to the ceiling, plaster work, décor and electrics in the area would have resulted in a significant repair cost. It was lucky that no one came out of their flats during the fire, as there would have been significant amounts of toxic smoke and hot fire gases.

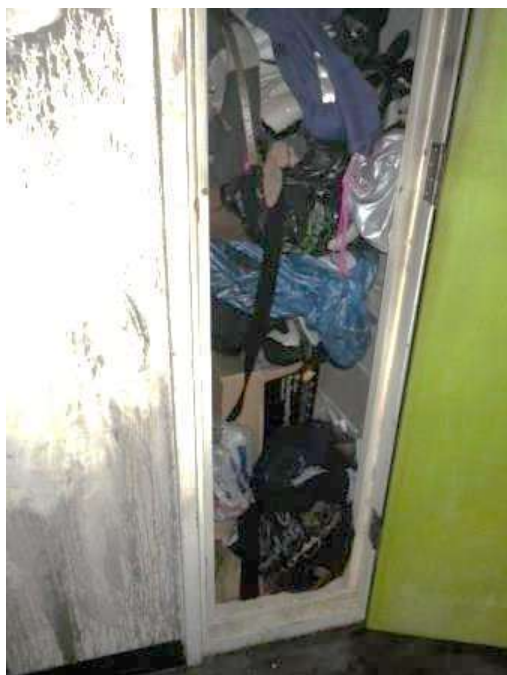
4.6 The three images on this page relate to a fire which occurred in a common lobby shared by 4 flats on the second floor of a high rise block. The seat of the fire was within a small cupboard (approximately 30-50cm wide) used to house services such as drainage and telephone cables. The cupboard had been filled with old clothes and electrical items (example image left).

Note: Risers in common areas should be kept locked shut to prevent inappropriate storage in these areas. This should be part of ongoing management / maintenance of the building.

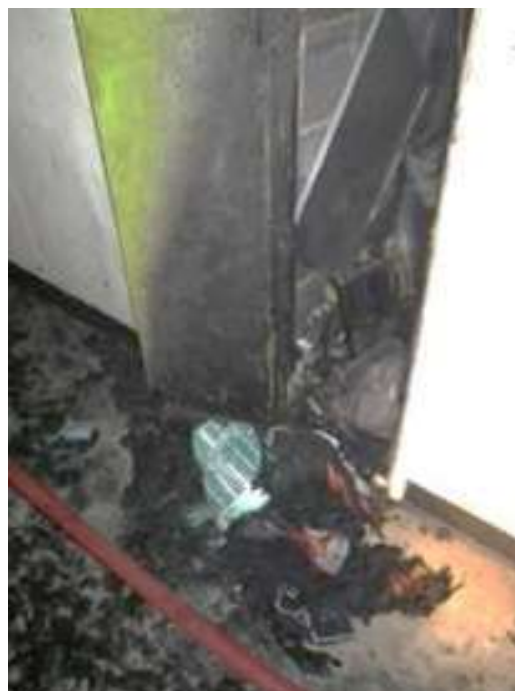
4.9 The image to the right shows the cupboard with some fire debris removed. There was not a huge amount of material involved, considering the extensive smoke damage, as seen in the image below.

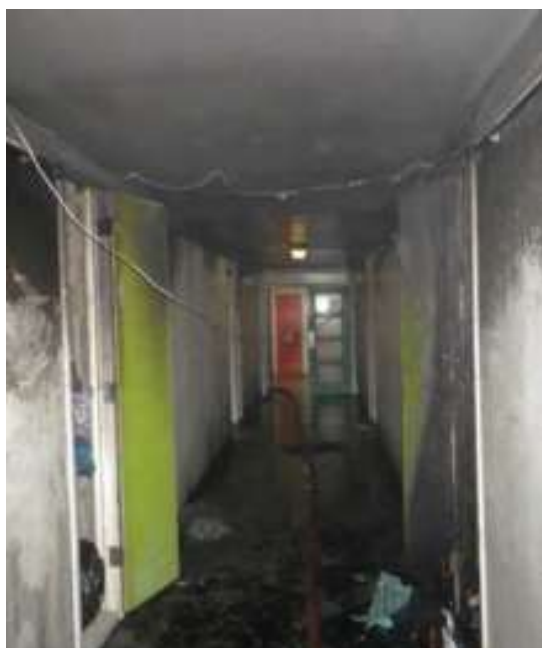
4.11 The fire was confined to the area of origin with the remainder of the lobby and corridor being damaged by heat and smoke.

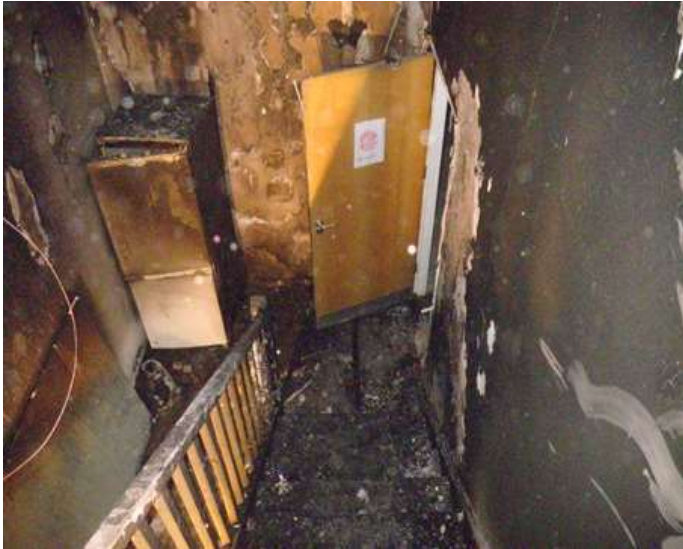
4.14 Fuelled by paper and stored goods, the fire started in the hallway on the ground floor offices at the base of the internal staircase to the flats (as shown in image to the left) and damaged approximately 50% of the ground floor. The remainder of the ground floor was damaged by heat and smoke, with the rest of the building damaged by smoke.

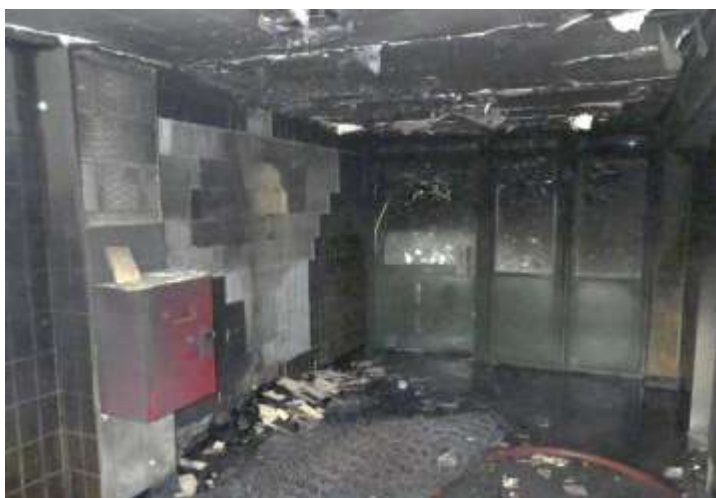
- 4.21 *Image above: View of communal area with the remains of the mattress in foreground. Note damage to ceiling and walls, doors and wall panels.*
- 4.22 *Image below: View from other side of doors. Note extensive damage to ceiling, walls, doors and wall panels. Light fitting and electrical wiring indicated by red arrow also damaged by fire.*

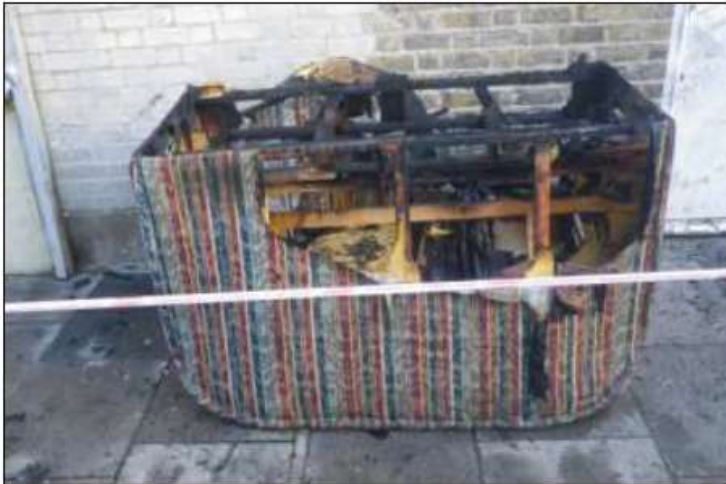
- 4.23 Two fire engines attended this fire in the communal hallway of flats in a low rise residential building. Occupants were unable to escape due to the location of the fire and smoke spread within the building.
- 4.24 The fire is believed to be caused by the careless disposal of smoking materials into paper (envelopes magazines and cardboard) which were on top of an abandoned two seat sofa in the communal area of the ground floor stairwell (image below), the sofa was only partially damaged, however:

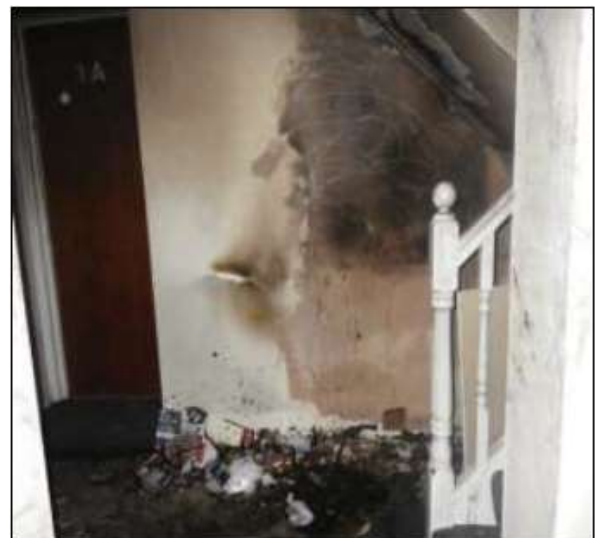
- 4.26 The image (to right) shows the area of origin where the sofa was. Note that the structural damage was not particularly severe in this case, but the smoke travel resulted in the rescues and injuries detailed above.

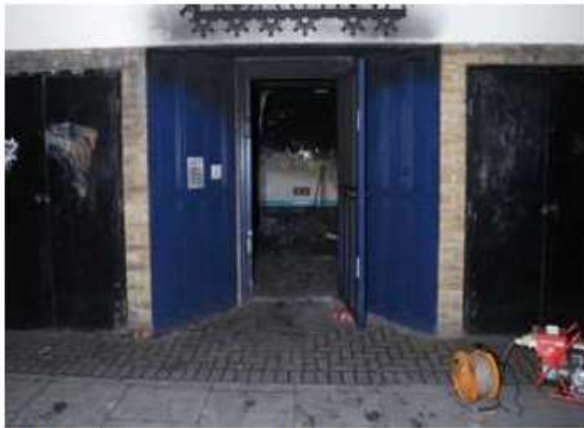
View of front communal entrance

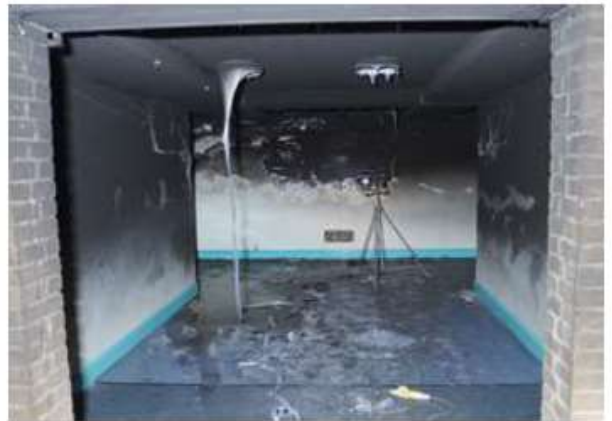
View going in through the communal entrance. Note light fittings have melted

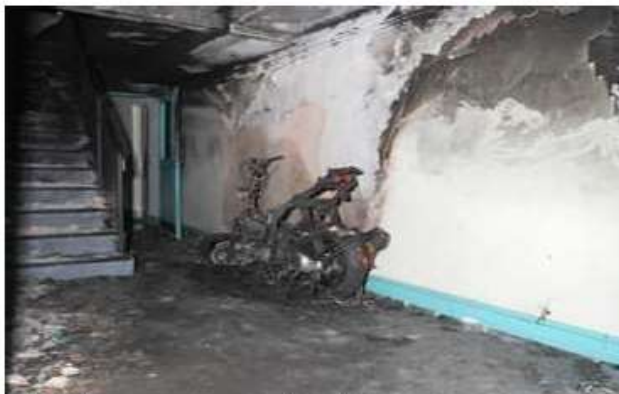
Clear burn pattern behind the scooter, Note rear tyre is still intact

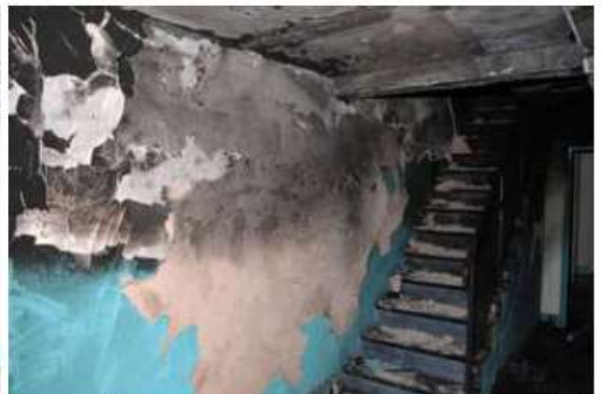
Stairwell opposite the scooter. Note; spalled plaster from the stairwell has fallen onto the stairs

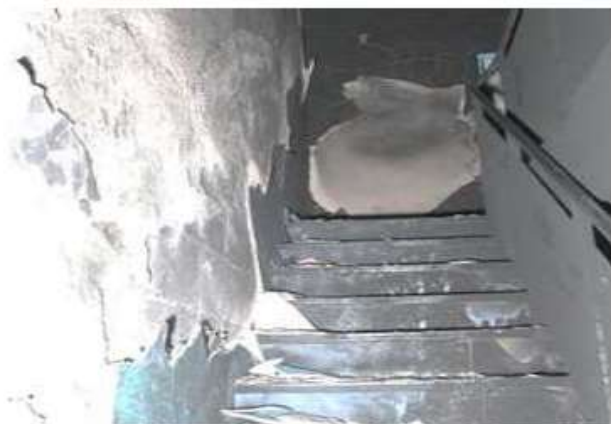
Image to left: View upstairs showing extensive heat and smoke damage.
